Monitoring Data Record

Project Title: R-2552B Clayton Bypass COE Action ID: 200220745  
Stream Name: Site 5 DWQ Number: 041760  
City, County and other Location Information: US 70 Clayton Bypass from I-40 to US 70  
Station 82+60 to 85+50 -L-  
Date Construction Completed: 4/21/06  
Monitoring Year: ( 4 ) of 5  
Ecoregion: \_\_\_\_\_ 8 digit HUC unit 03020201  
USGS Quad Name and Coordinates: \_\_\_\_\_

# R-2552B Clayton Bypass

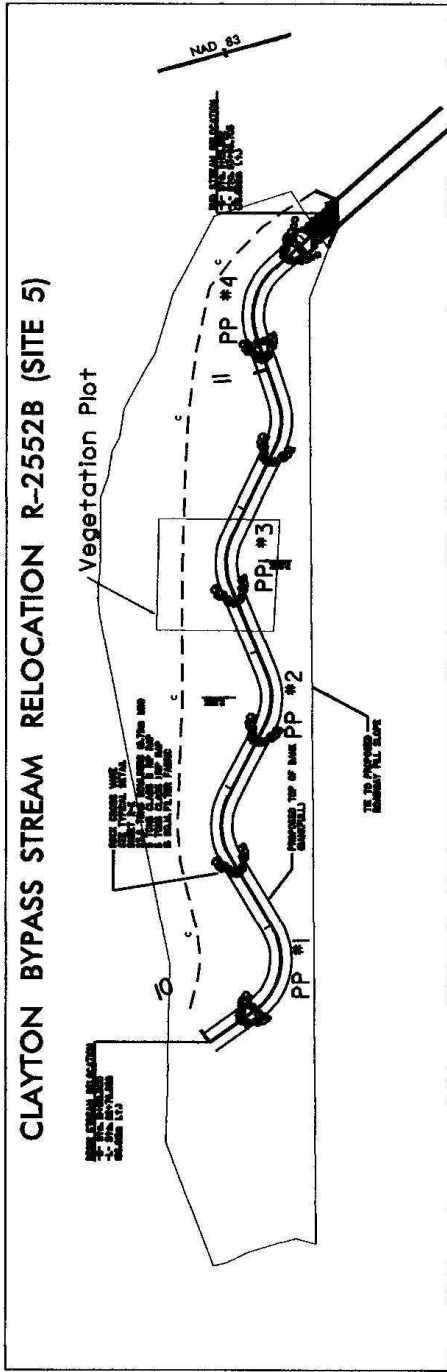
The stream relocation is stabilized for the Year 4 Winter evaluation, except for some minor bank scouring on the right bank at Photo Point #4 (Sta. 11+10-S-). There is also some erosion at the inlet end of the box culvert around the right wing wall. NCDOT is planning to repair the area around the right wing wall in the near future. NCDOT will continue to monitor the channel stability at this stream relocation.

Erosion at inlet end of box culvert around right wing wall
